# The Bagdad Village Historic District Report & Maps

By Sara Campney & Krystal Caylor  
Santa Rosa County Planning & Zoning

## Bagdad Village Historic District Assessment

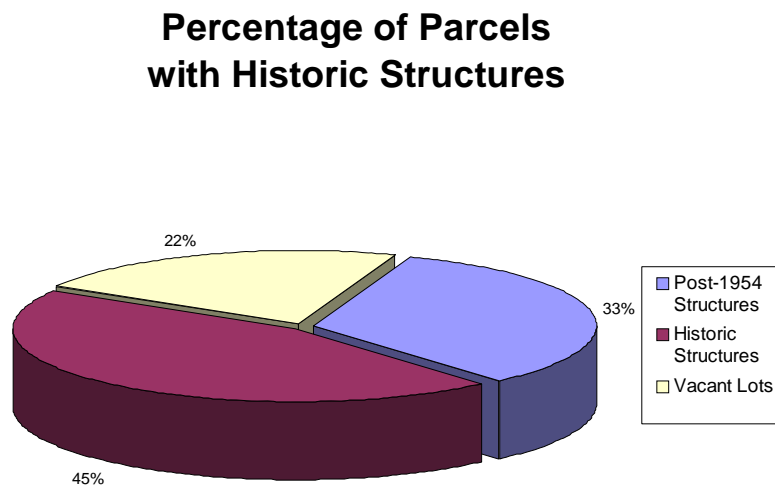
Figure 1

Even though the structures in the district are still primarily historic, the potential for the make-up and character of the district to change in the near future is real. 33% of the district is already comprised of newer homes and 22% of the parcels in the district and historically zoned area are vacant lots (See Figure 1). When looking at the size of vacant parcels that fall at least partially into the historic district boundary and those that are at least partially zoned historic, it appear that 42% of the acres are vacant. However, this number is misleading because it includes a 70-acre tract of land that is adjacent to the Bagdad Cemetery that has less than 10% of its area within the district and zoning boundaries.
